PROJECT DOSSIER

Doha Marriott Hotel, Qatar

PROJECT OVERVIEW

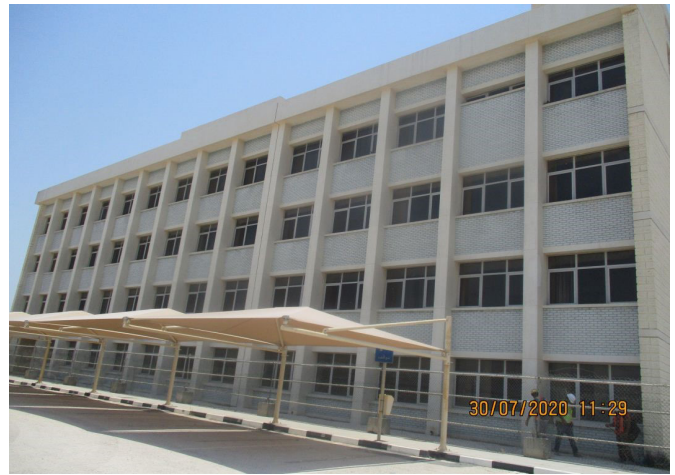
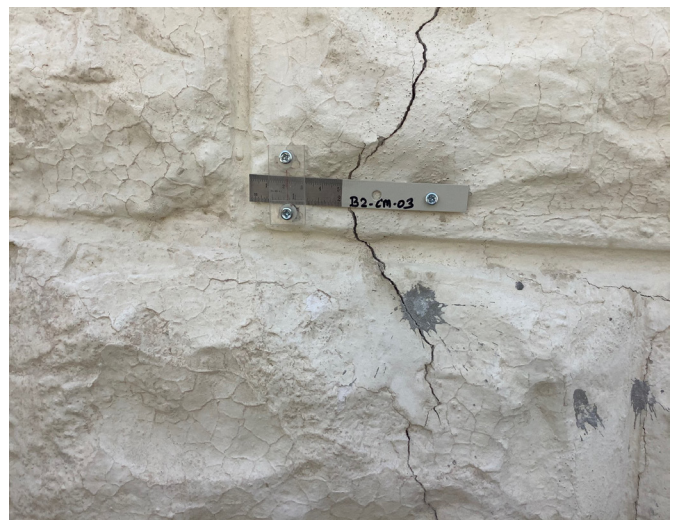
Model EDJ-40C Crack meter installed

A number of Model EDJ-40C mechanical type surface mounting uniaxial crack meters were used to monitor the change in width of the existing cracks on the four existing structures.

The installation of crack meters was bit challenging as the buildings were quite old with uneven outer surface.
