CASE STUDY

High rise building Instrumentation & monitoring during construction

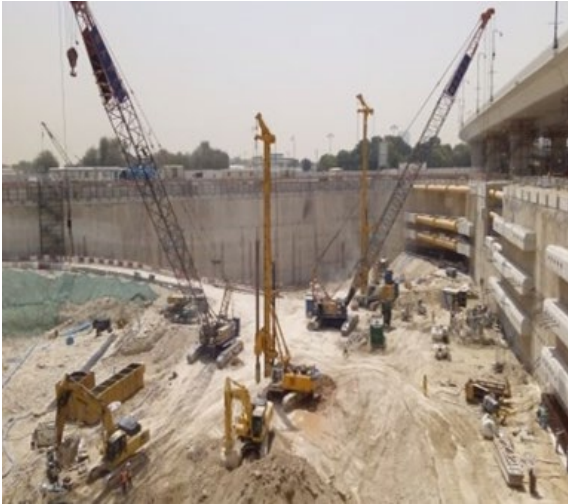
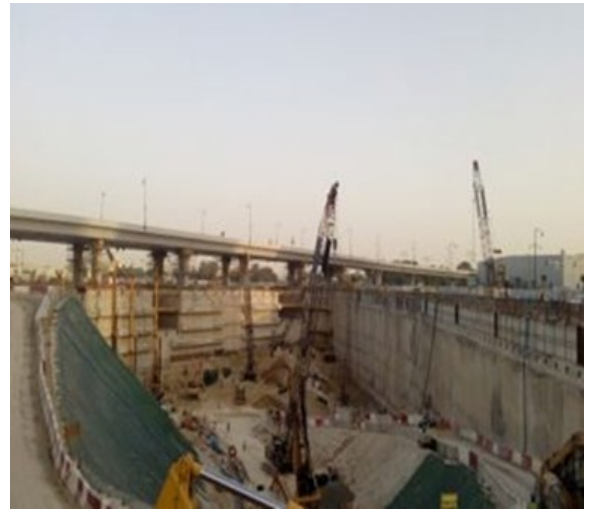
Figure 1 Inclinometer INC-09 observed movement of up to 15 mm. This alerted shoring contractor who then used anchoring to support D-walls near the bridge. The impact of anchoring was visible in our inclinometer readings, as they got stable after anchoring.

Inclinometer were installed in diaphragm walls to measure lateral movement in diaphragm walls (D-wall) during deep excavation works for Tower A & B. The D-walls went more than 45 m below ground level.

As this was quite deep, first of its kind with 7 basement levels, lateral deformation of D-wall was expected during excavation and became critical for monitoring. This was also observed in some inclinometers data, where the graph represented significant lateral movement, as shown in figure 1. The variations were informed to construction team promptly. This alerted the construction team timely to take necessary preventive actions.

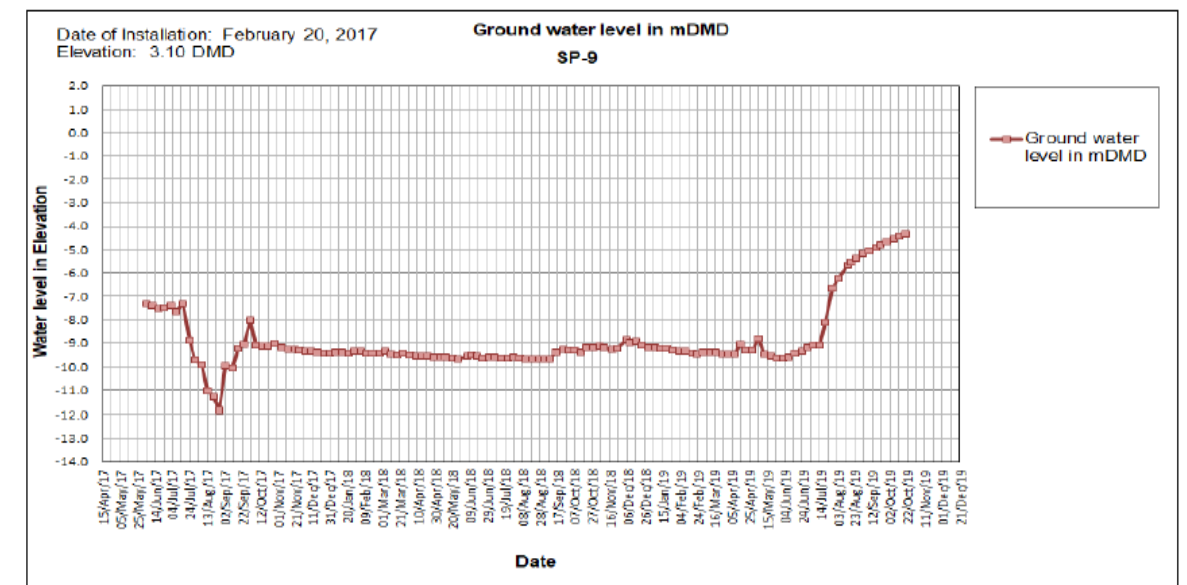
Figure 2 Ground water level data from Standpipe SP-9, showing rise in water level when dewatering stopped

In the particular water level data from Standpipe shown below, it is seen that when dewatering was stopped, water level started to increase. On taking corrective control by contractor, it got stable.

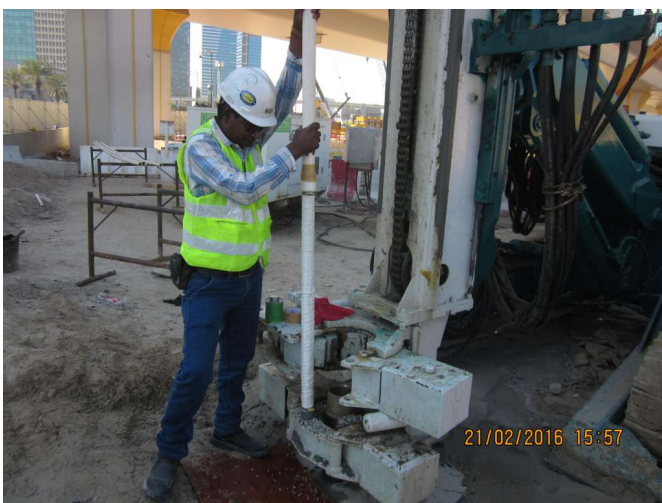
Figure 3 Standpipe piezometer (left) and inclinometer (right) being installed

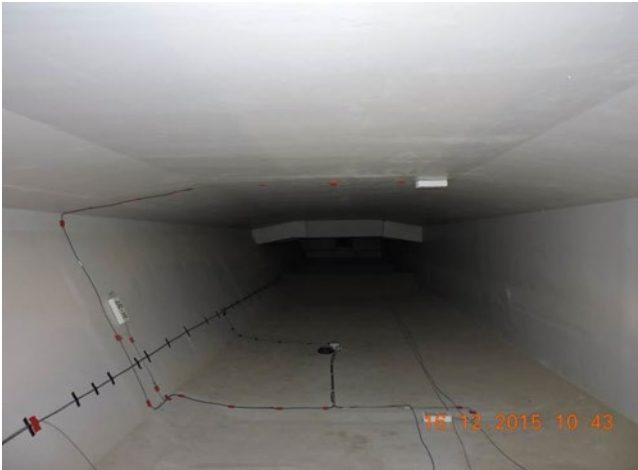
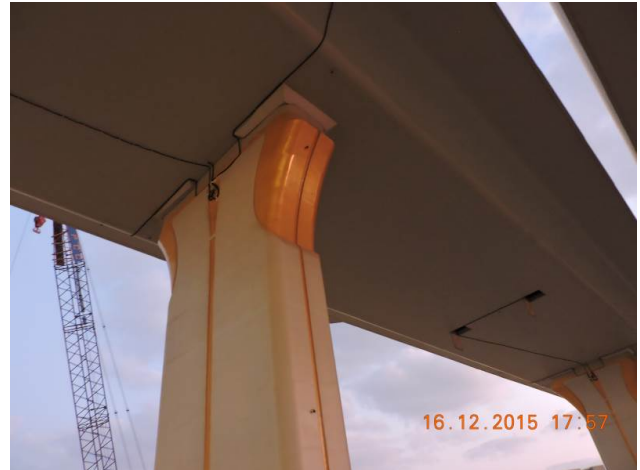
Figure 4 Strain gages installation on bridge

Change in stresses were expected in the existing road bridge due to deep excavation and dewatering nearby. Vibrating wire strain gages were installed on bridge to monitor the stresses. Change in stress was obtained by multiplying the measured change in strain by the modulus of elasticity of concrete.

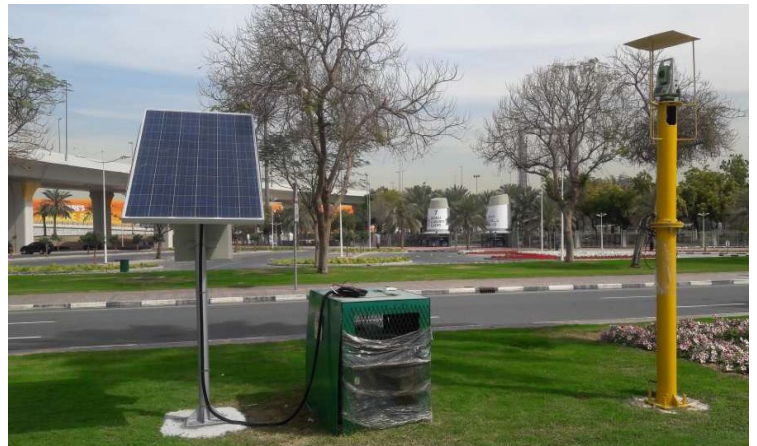
Figure 9 Prism target locations on the bridge pier (left). Automatic total station to collect and transmit data from prism targets installed on bridge (right)

Monitoring 3D movements of the bridge were vital to ensure there was no structural impact on the bridge due to ongoing site activities. Prism targets were installed on the bridge to monitor 3D movements. Three automatic total station with control boxes were used to collect and transmit the prism targets data at every 20 minutes.

For each pier, 4 prisms were taken into account for the analysis. Two prisms on the top of the pier, two prisms on the bottom of the pier (refer to figure 9). The database software also averaged the values of prisms at same level of the piers.

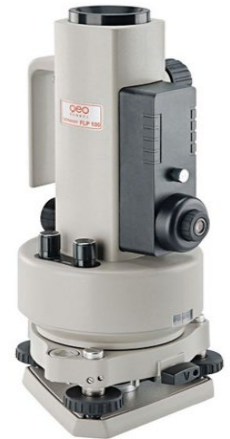
Figure 14 Typical layout (left), image results (right) while working with optical laser plummet

Every measurement in the grid was recorded as the monitoring reading. It was then converted into picture, recorded and sent to the data base. Each hole had a unique code shown in each picture. The picture also included day, time, position and measurement (laser projection). This prevented any risk of error

Each measurement on the grid directly showed the relative displacement of the slab when it was compared with the initial reference value of the first measurement on the grid.
